# **ASSESSMENT OF THE HARSTVILLE, SC AFRICAN AMERICAN CEMETERY**

**Chicora Research Contribution 563**

Michael Trinkley

August 2015

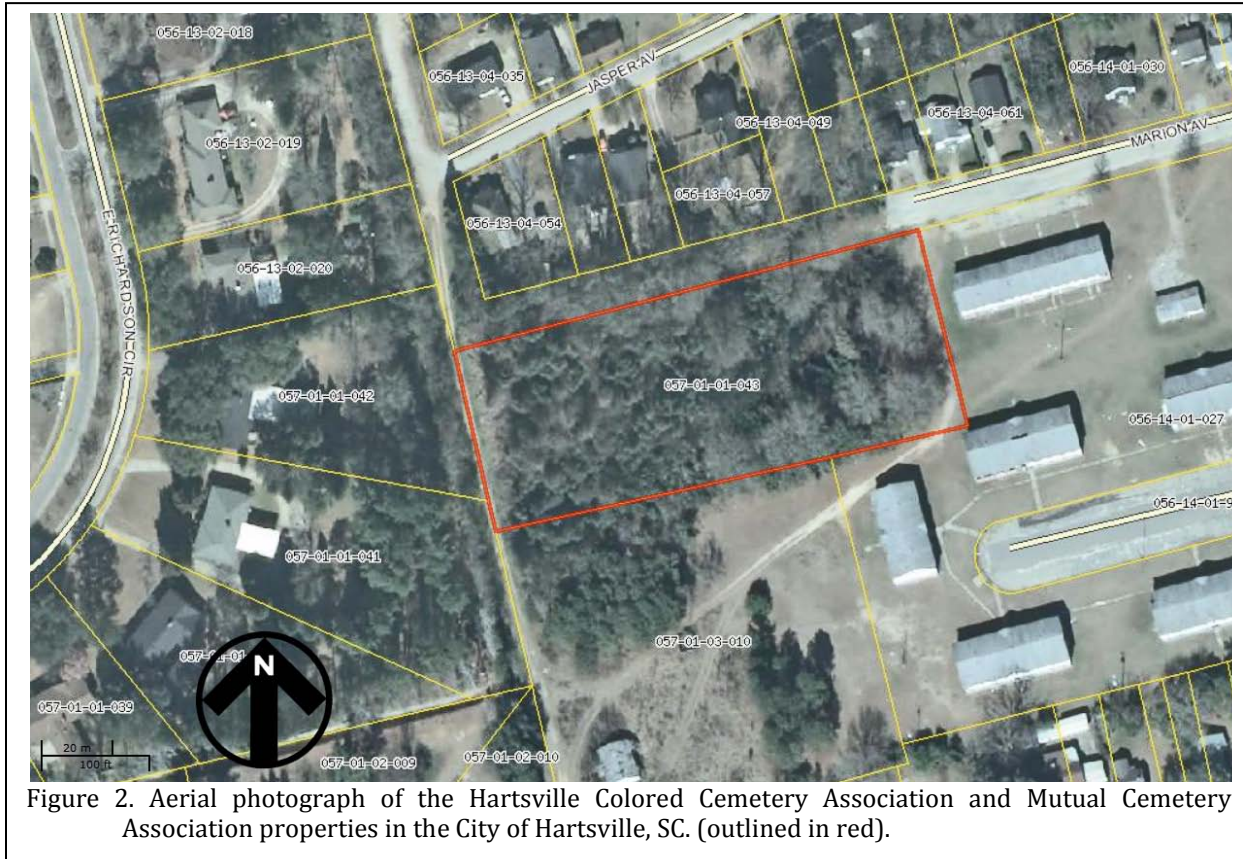
Figure 2. Aerial photograph of the Hartsville Colored Cemetery Association and Mutual Cemetery Association properties in the City of Hartsville, SC. (outlined in red).

The cemetery is identified by Darlington County as parcel 057-01-01-043, combining both of the cemeteries into one parcel they identify as the "Hartsville Colored Cemetery" (Figure 2). The Register of Deeds also lists the City of Hartsville as the owner, apparently based on the City's 1976 assumption of responsibility for the property.

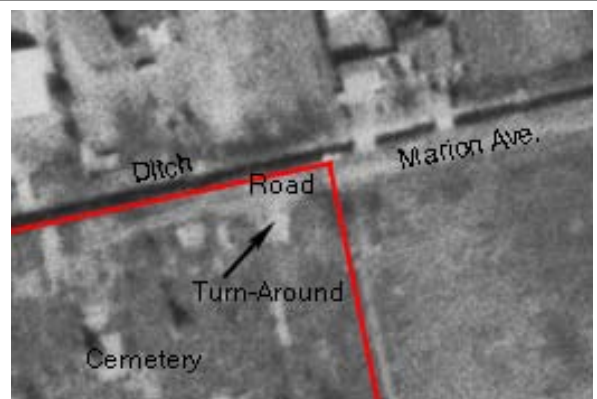
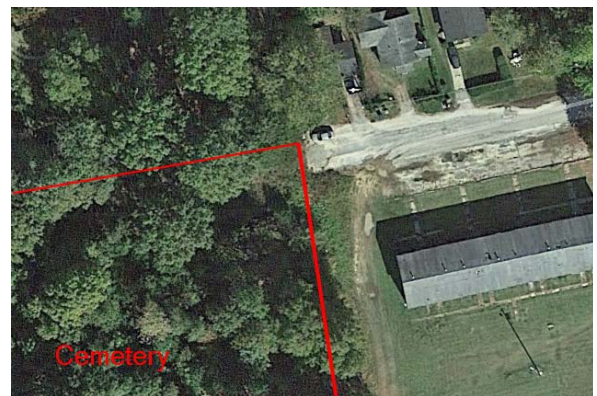
Figure 11. Road into the cemetery. Upper photo shows the area in 1964. The lower photo shows the area in 2014.

the cemetery's current low visitation. Any effort to re-establish the pre-existing dirt road and turn-around in the cemetery would require investigations to ensure that no graves would be damaged. It is far easier to create new parking.

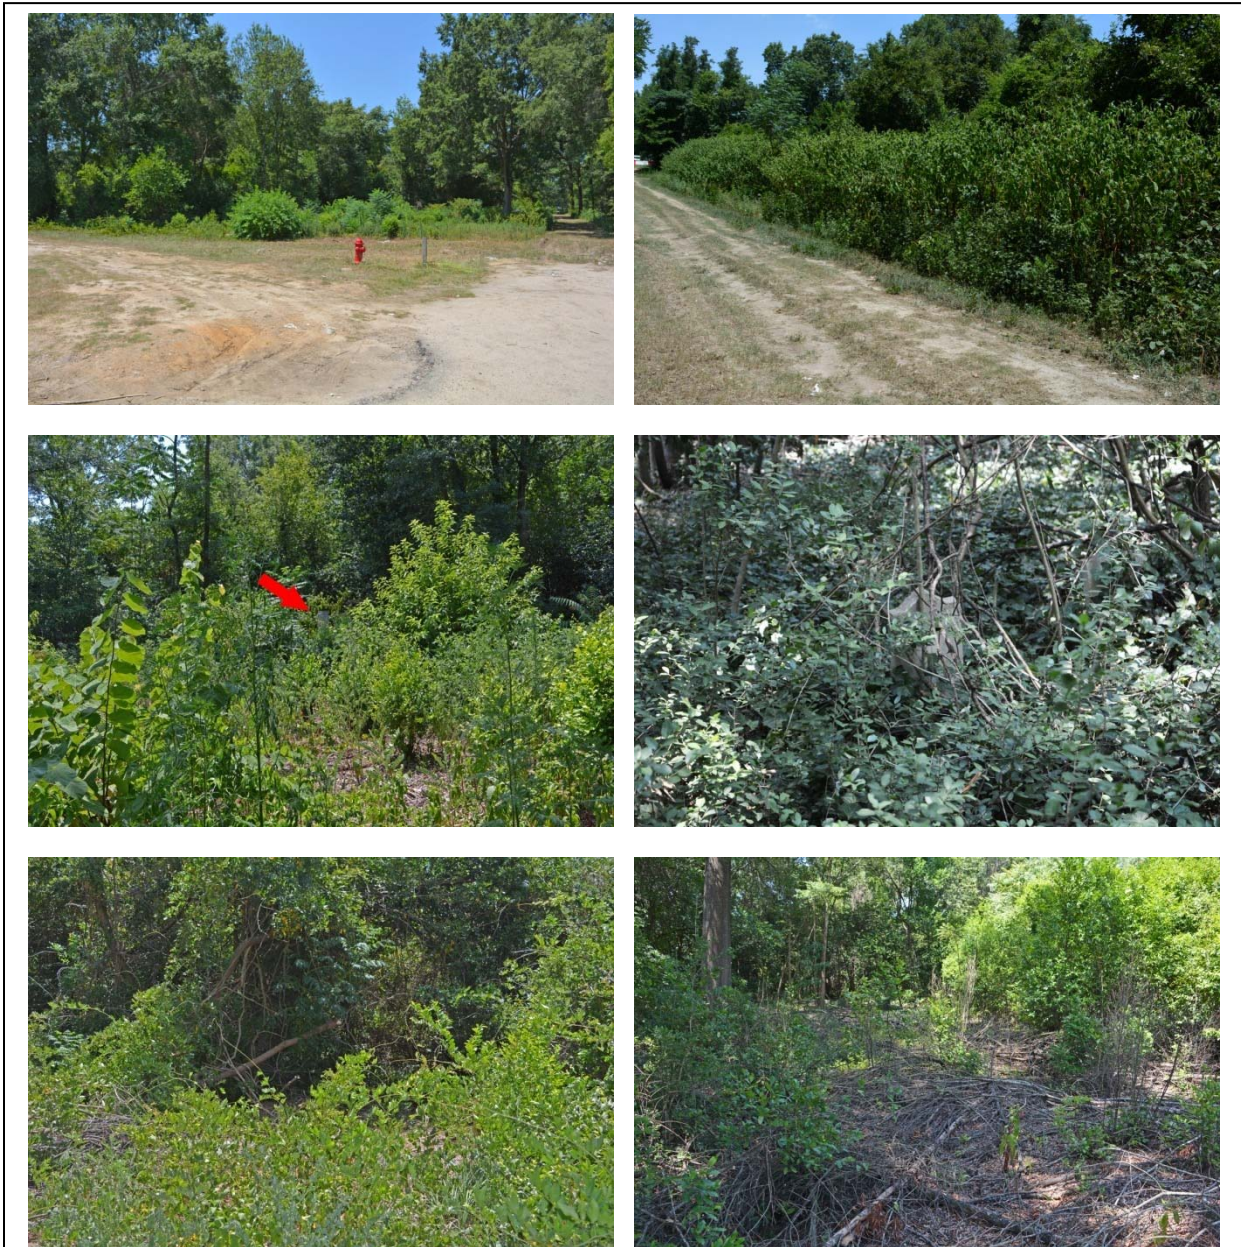
Figure 12. Vegetation in the Hartsville cemeteries. Upper left photo is looking southwest at the northeast corner of the cemetery from Marion Avenue. Upper right photo shows dense pokeberry in the northwest corner of the cemetery. Middle row photos show two stones in the cemetery nearly hidden by dense vegetation. Lower left photo shows dense vines and dead wood. Lower right photo shows dense dead vegetation left behind after the last clean-up effort.

All downed vegetation should be gathered up and removed from the cemetery by hand. A good stacking point would be the large vacant space associated with Lincoln Village at the southeast corner of the cemetery.

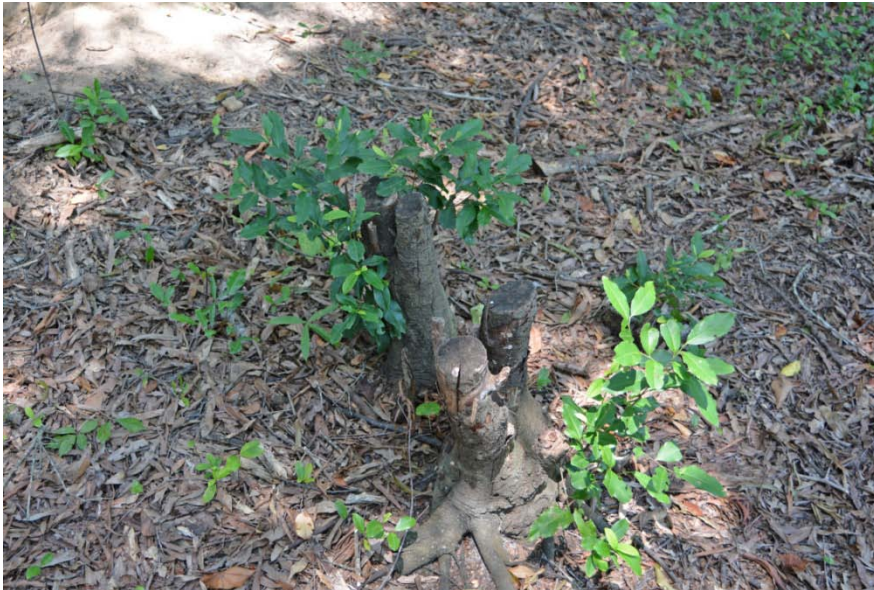
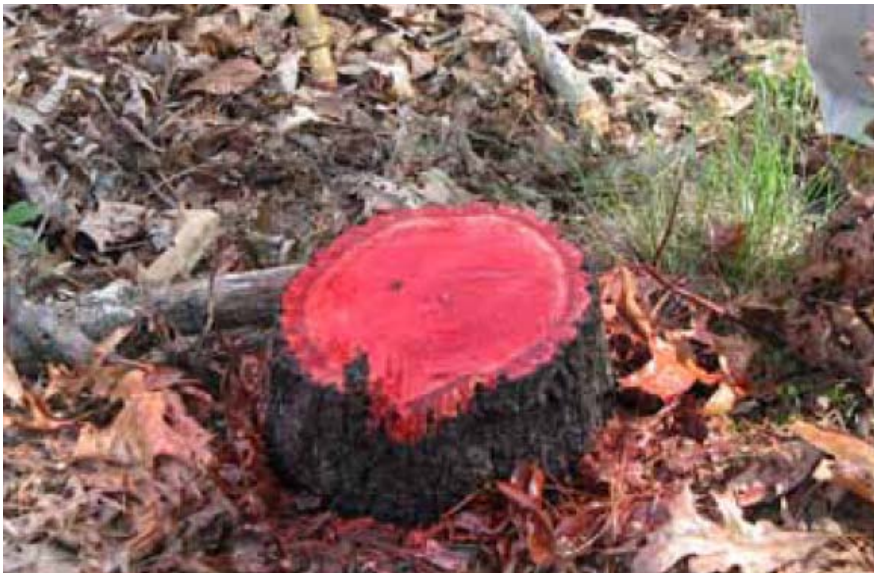
Figure 13. Examples of incorrectly and correctly cut stumps. The upper photo shows a stump cut too high and left untreated, now beginning to put out suckers. The lower photo shows a stump cut flush to the ground and treated with a 30% Garlon 4 Ultra in a commercially available basal oil with a marker dye (Fluorescent Red Liquid Concentrate).

sucker or put out additional growth (see Figure 13). To avoid this one individual should be assigned the task of painting all freshly cut stumps with a 30% Garlon 4 Ultra in a commercially available basal oil. We also recommend the addition of a colorant so it is easier to determine

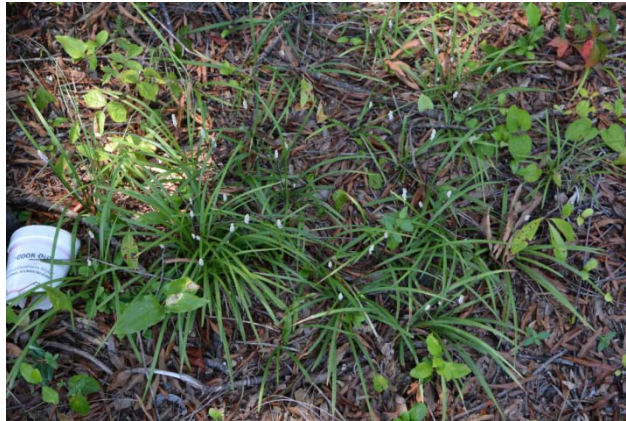
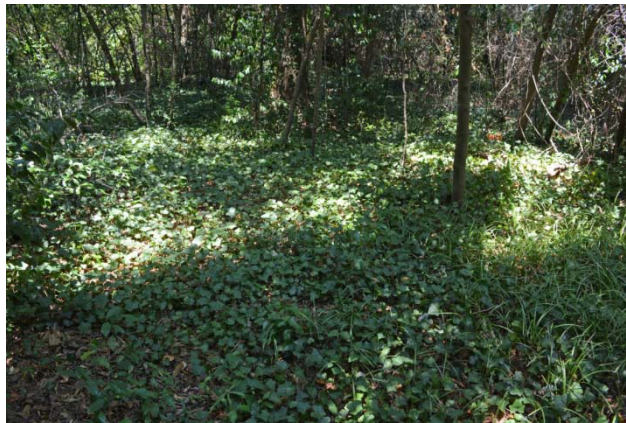
Figure 14. Examples of intentionally planted vegetation. Upper photo shows a small patch of liriope. Lower photo shows a large expanse of English ivy.

knowledgeable individual should be overseeing the removal at all times.

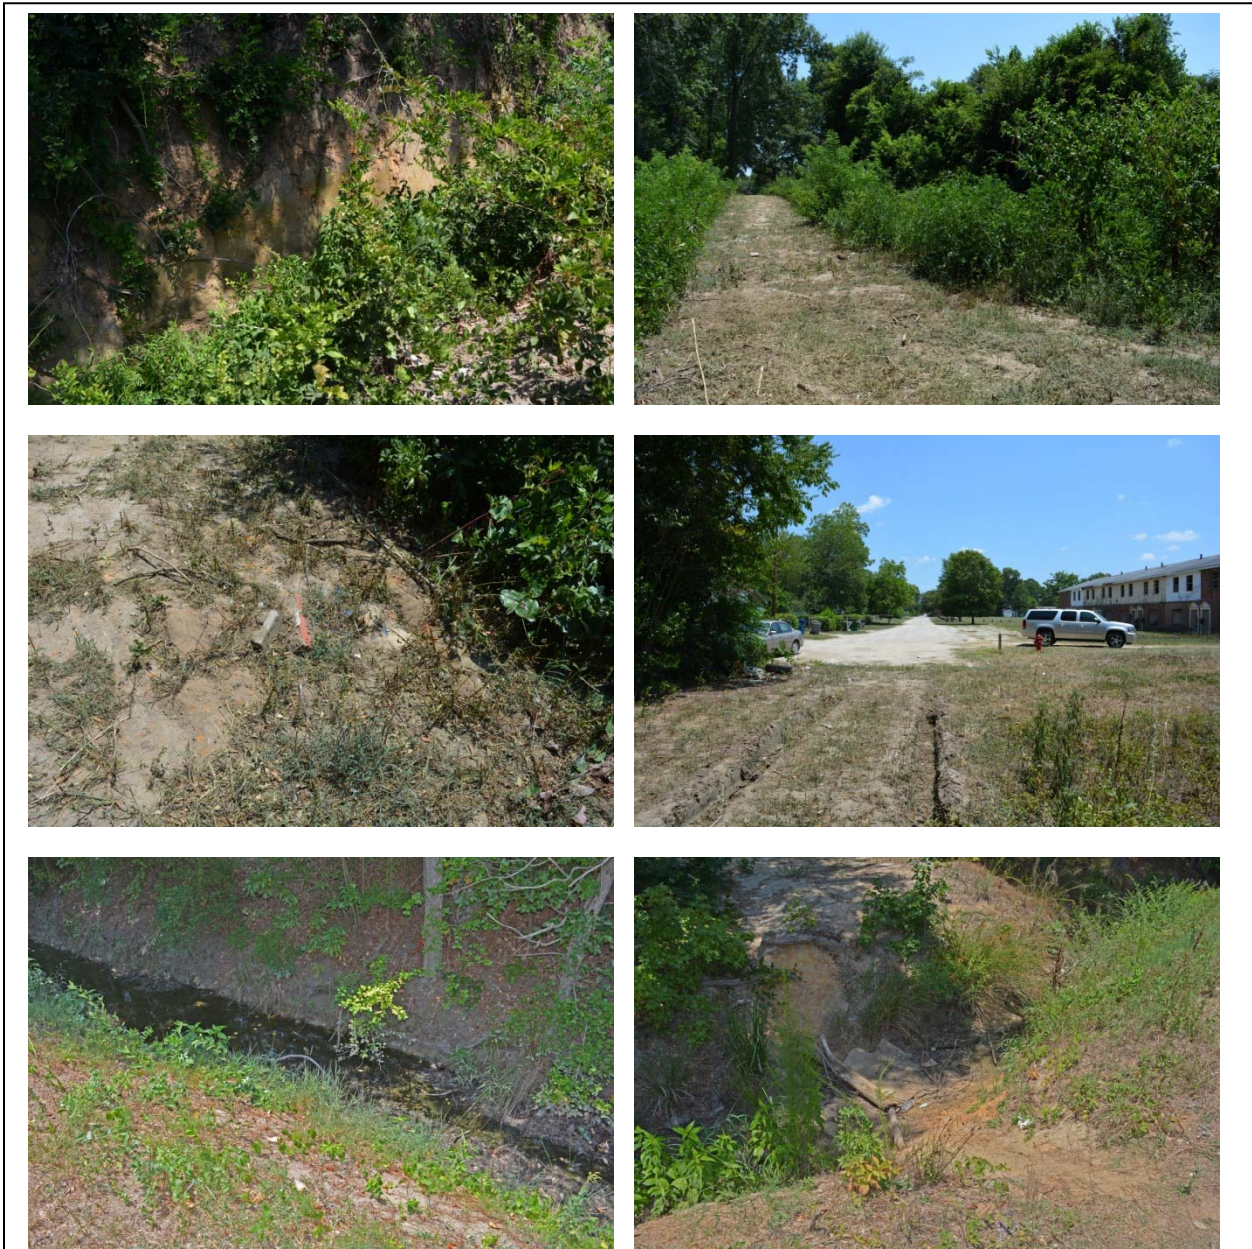
It is important to observe that in the early 1960s the northern ditch was open along the north side of Marion Avenue well past the cemetery to the east. At some point this ditch was converted to a buried culvert. We recommend that grant funds be sought to accomplish the same for the remainder of the northern and western ditch in the immediate area of the cemetery.

Figure 16. Ditches bordering the cemetery. Upper left photo shows the steep bank of the ditch along the north edge of the cemetery. Although recently cleaned, vegetation is already beginning to overtake the ditch from the north. Upper right photo shows the “easement” created where none exists. The cemetery is to the right of the photo. Middle left photo shows brick and stone in the “easement.” Middle right photo shows deep ruts created in the “easement” by the equipment needed to clean the ditch. Lower left photo shows stagnant water in the western ditch. Lower right photo shows a social trail through the ditch and trash that prevents water flow.

These ditches can either be changed from open to piped ditches or covered drains or the ditches can be re-engineered with canal linings of concrete in order to increase flow velocities, reduce aquatic weed growth, and allow for manual cleaning.

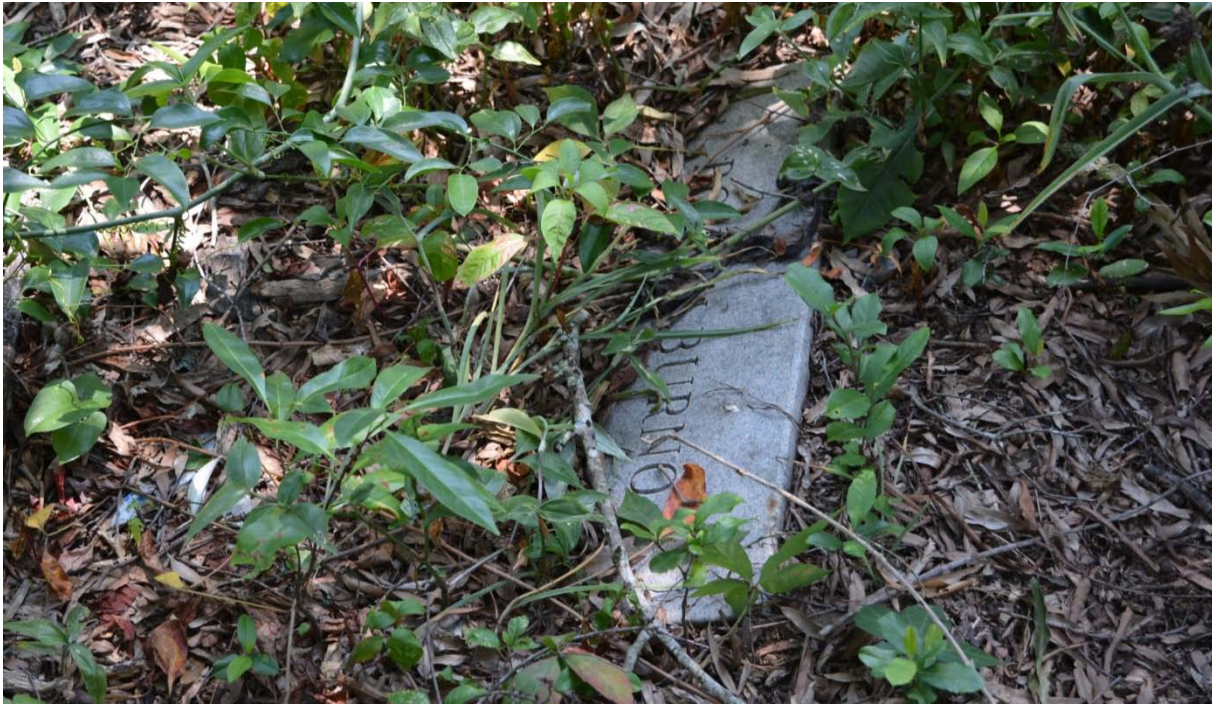
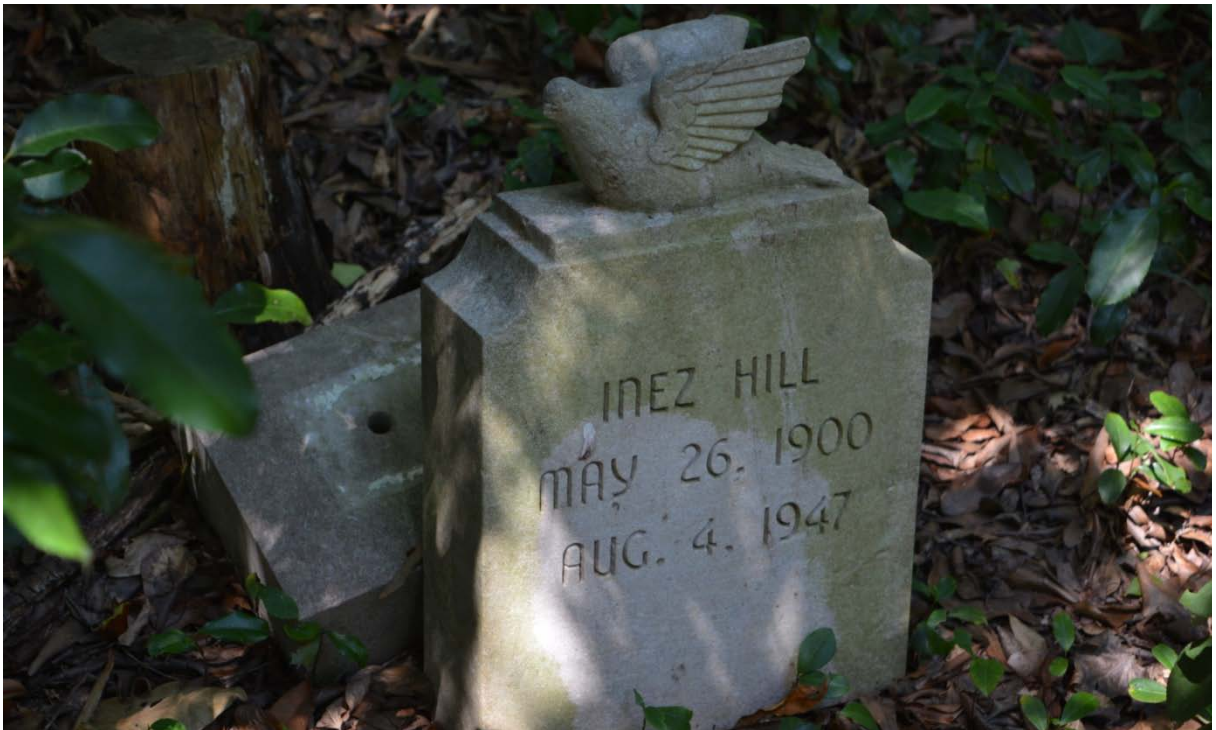
Figure 16. Stone problems. Top photo shows a sunken stone. Bottom photo shows a toppled stone with ferrous pins.

All cemeteries have a number of granite or marble die on base stones that were originally set using setting compound. This is a commercial product typically consisting of calcium carbonate, talc, and occasionally calcium silicate in linseed oil or a similar material. It is designed to be applied under a granite monument to help seal it to base and prevent water intrusion. Because it contains oil it may leave a halo on marble and should only be used for setting granite monuments. Setting compound is not an adhesive and will eventually dry out. It also does not prevent a monument from being tipped over, so care must be taken when the monument being set is top heavy, very tall, or is in a setting where vandalism is likely. In such cases it is good practice to set the monument not only

with setting compound, but also with one or more fiberglass pins.
