*Central Burying Ground
Carlisle, Massachusetts*

Preservation Master Plan

*prepared for the
Town of Carlisle Historical Commission*

*Martha Lyon Landscape Architecture, LLC
Fannin-Lehner Preservation Consultants
CME Associates, Inc.
Carlisle Arboriculture*

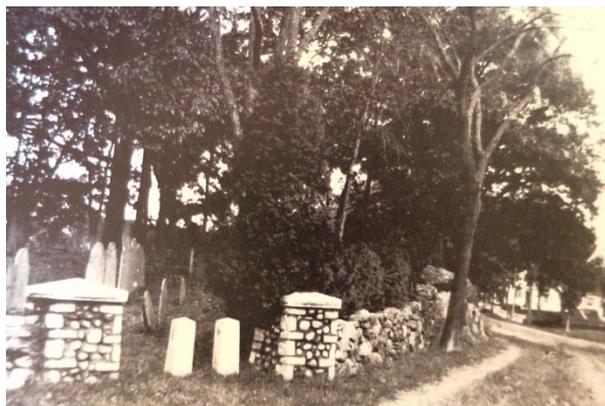
A ca. 1890 photograph of the southeast entrance shows the Arbor vitae hedge and cedar tree. Images of America: Carlisle

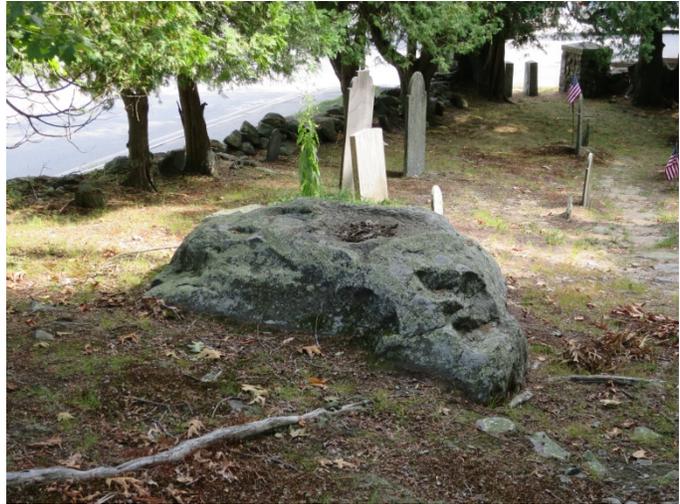
The natural outcropping became the centerpiece of a rock garden, made in 1933 in honor of Mrs. T. A. Green, the rock's depression deepened to create a bird bath.

In the 1930s, the Carlisle Garden Club planted a rock garden around this prominent cemetery feature. The garden is one of several historic features missing from the burying ground landscape.

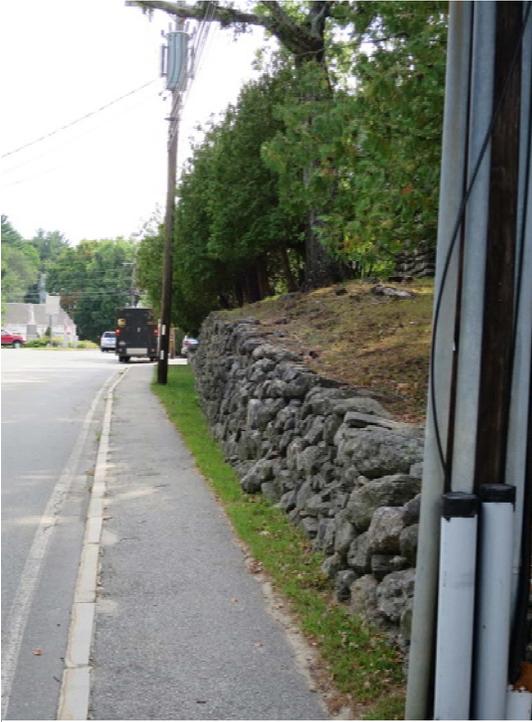
The stone wall was reconfigured into a retaining wall in the 1930s when ledge was removed along the east side of the burying ground. In the late 20th century, the original concrete sidewalk was replaced with bituminous asphalt, and utility poles installed against the wall.

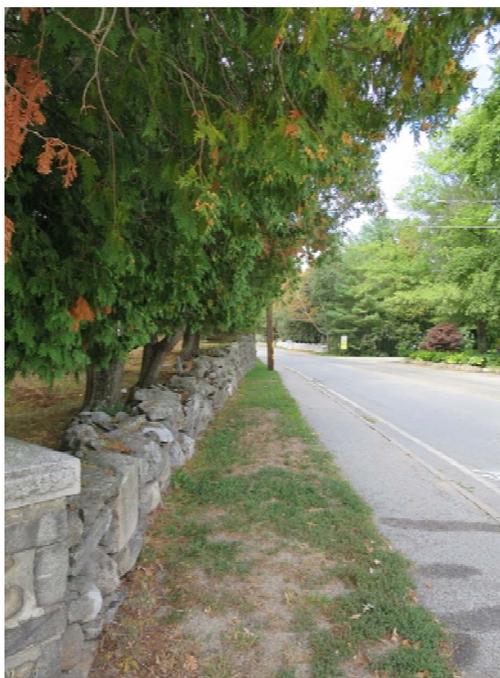
*A field stone wall lines the eastern burying ground edge, providing a strong buffer from the busy Lowell Street thoroughfare. Overgrown *Arbor vitae* shrubs detract from the appearance of the wall and also block views from outside, into the burying ground.*

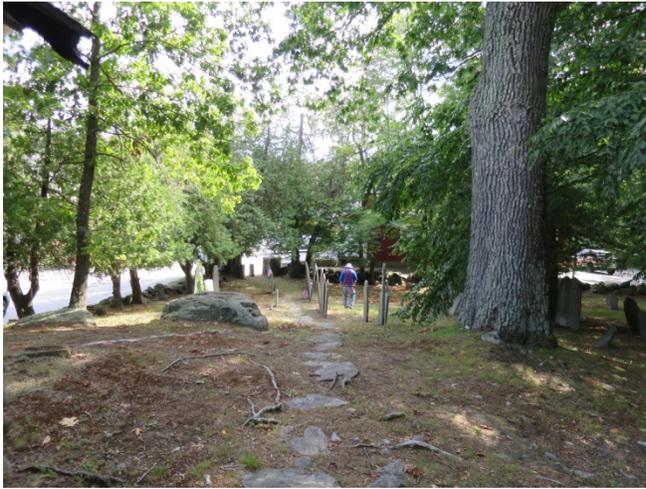
A stepping stone path, added in 1930, connects the two burying ground entrances. While the path is inaccessible, it is a prominent historic feature.

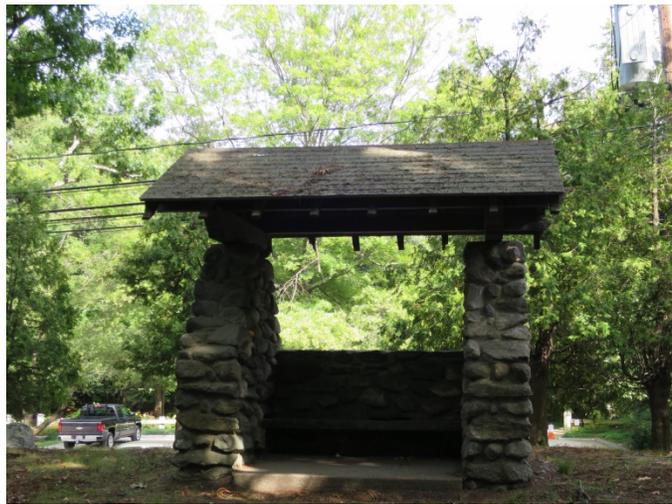
Litchfield Memorial Seat (Shelter). This mortared stone structure, constructed in 1928, contains a heavy wood framed roof with asphalt shingles. Overall the structure appears in stable condition, with only minor cracks in the mortar joints (caused by settlement or thermal expansion). Re-pointing has occurred since its original construction. The most significant sign of decay is in the wood roof framing, which contains several broken eave ends, and severe rot on the main beam on the east side. Vandals have carved initials into some of the wood surfaces.

The Litchfield Memorial Seat (shelter) is the burying ground's most prominent structure. Constructed on mortared field stone with a heavy wood timber roof frame, it has stood the test of time, showing only minor decay.

Project #3 involves stabilization and restoration of the Litchfield seat, the mortared stone and timber-framed roof structure, located at the highest point in the burying ground. As noted in the Engineering Assessment, the seat is in good condition, with little sign of movement or failure. Stabilization will include cleaning the stones, removing graffiti and re-staining the wood. Restoration will involve replacing a rotted beam, repairing rafters, repairing cracked pointing, re-pointing un-matching mortar,

Costs for Project #3 include replacing rotted beams, repairing/replacing damaged rafters; filling graffiti carvings, replacing the roof with cedar shingles, re-pointing portions of the base, staining the woodwork, and cleaning the stone surfaces of the Litchfield seat. All masonry work will need to be completed according to specifications written by a preservation architect and/or engineer experienced with restoration of historic masonry structures. The project will also include re-planting of a pair of spruce trees, and construction of a small rock garden at the adjacent outcropping. *Note: the budget projection assumes that the rock garden will be implemented by the Carlisle Garden Club.*

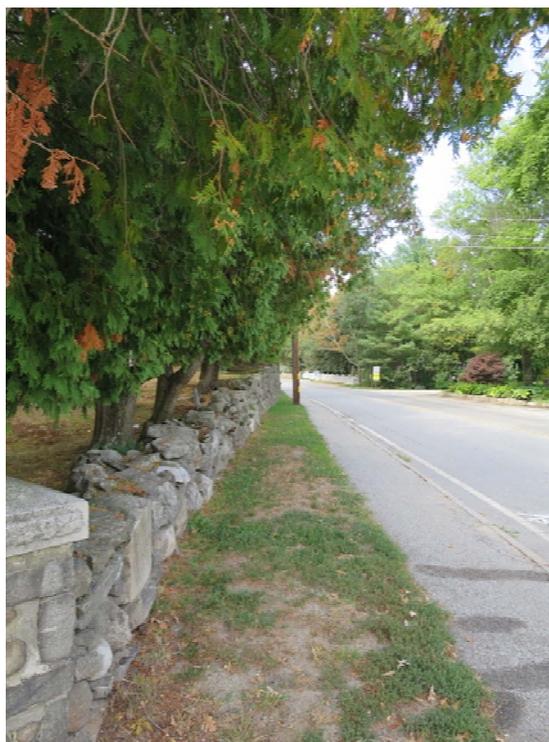
Arbor vitae plantings, once a hedge, will be removed under Project #1.

Project #1 involves two tasks related to the burying ground's trees, tree removal and tree replanting. The Tree Assessment (*Appendix C*) identified as many as 44 (out of 58 total) trees to be removed from the burying ground. The reasons for removal include (1) tree is overgrown; (2) tree is near and/or negatively impacting headstones; (3) tree is impacting the structural integrity of a wall; (4) tree species is invasive; (5) tree or portion of the tree is likely to fail. Removal of all trees from the interior of the burying ground would severely alter the landscape's character, therefore Project #1 will retain the healthiest trees, representing a diversity of species, while at the same time allowing for some sun to infiltrate and providing visibility into the burying ground from the outside.

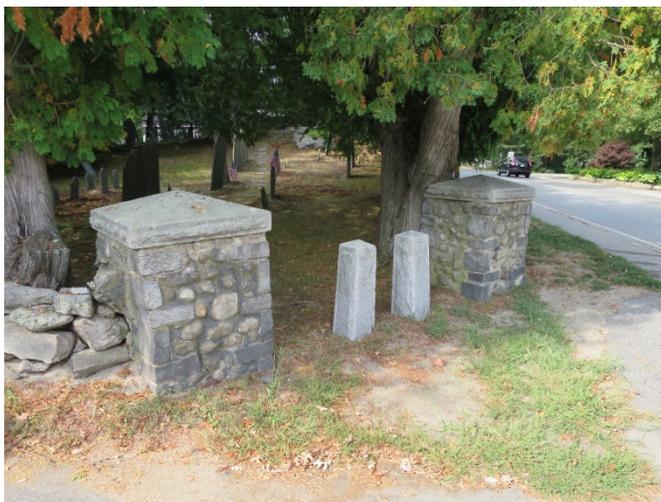
To create an accessible entrance to the burying ground, granite paving will be installed outside the existing columns, abutting the existing sidewalk and driveway, as part of Project #5.

The final project, Project #5, involves construction of a small entry “foyer” at the southeast burying ground corner. In this location, the natural topography is fairly level, allowing persons with all levels of physical ability to enter and travel a short distance into the burying ground, far enough so that they can scan a significant portion of the landscape. The project will include the following:

- Stabilization of entry posts, including re-point joints and cleaning stone surfaces;
- Removal of the existing bollards;
- Construction of a stable surface outside of the entry posts, flush with the adjacent sidewalk and driveway pavement;
- Design, fabrication and placement of an interpretive sign, located inside the entrance, allowing visitors to learn about the burying ground’s history and those interred within.
- Setting of granite edgestones, installed flush with the grade, marking the former location of the hearse house (near the southeast corner).
